Earthquake-Induced Ground Fissuring in Foot-Slope Positions of the Port Hills, Christchurch

A thesis

Master of Science in Engineering Geology

University of Canterbury

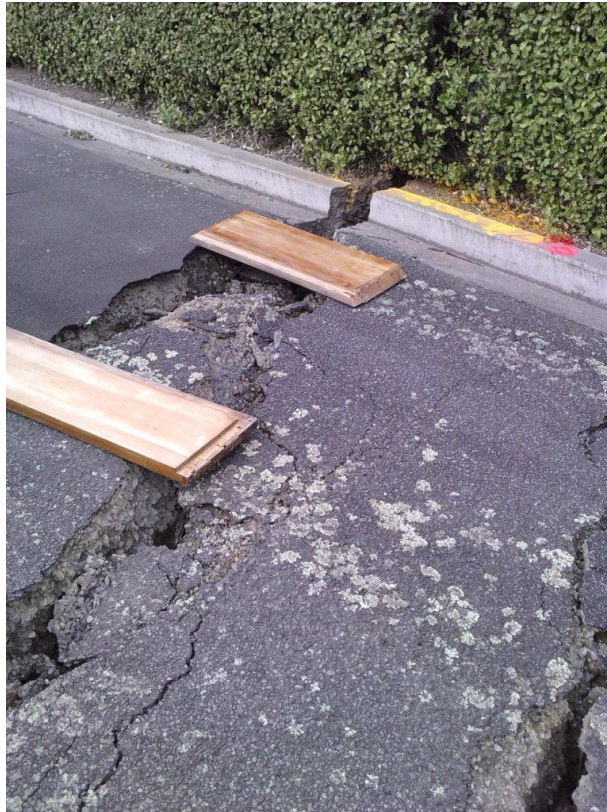
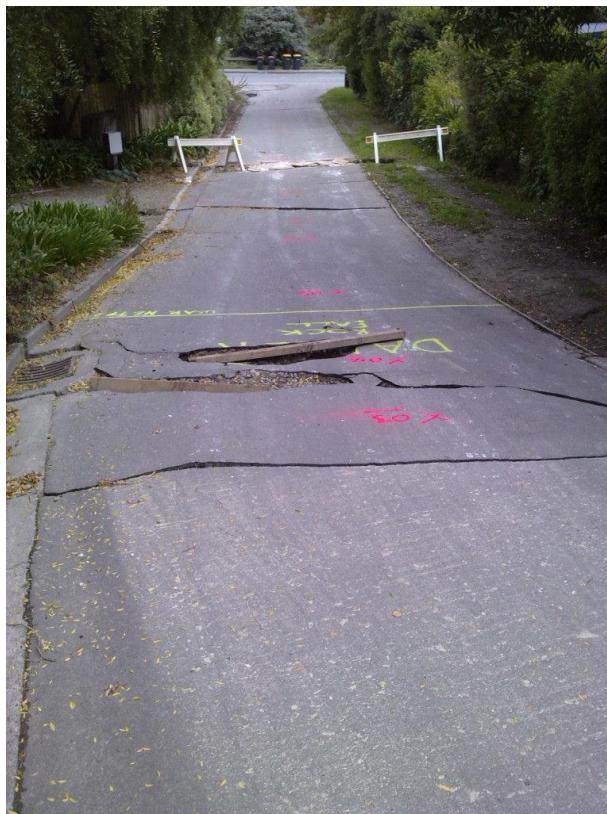
Figure 3.12 Upper: cracking in the driveway of 158A Bridle Path Road, and lower: tension cracks across Hammerton Lane, looking towards Bridle Path Road. Engel and MacFarlane, unpublished memo, 2011.

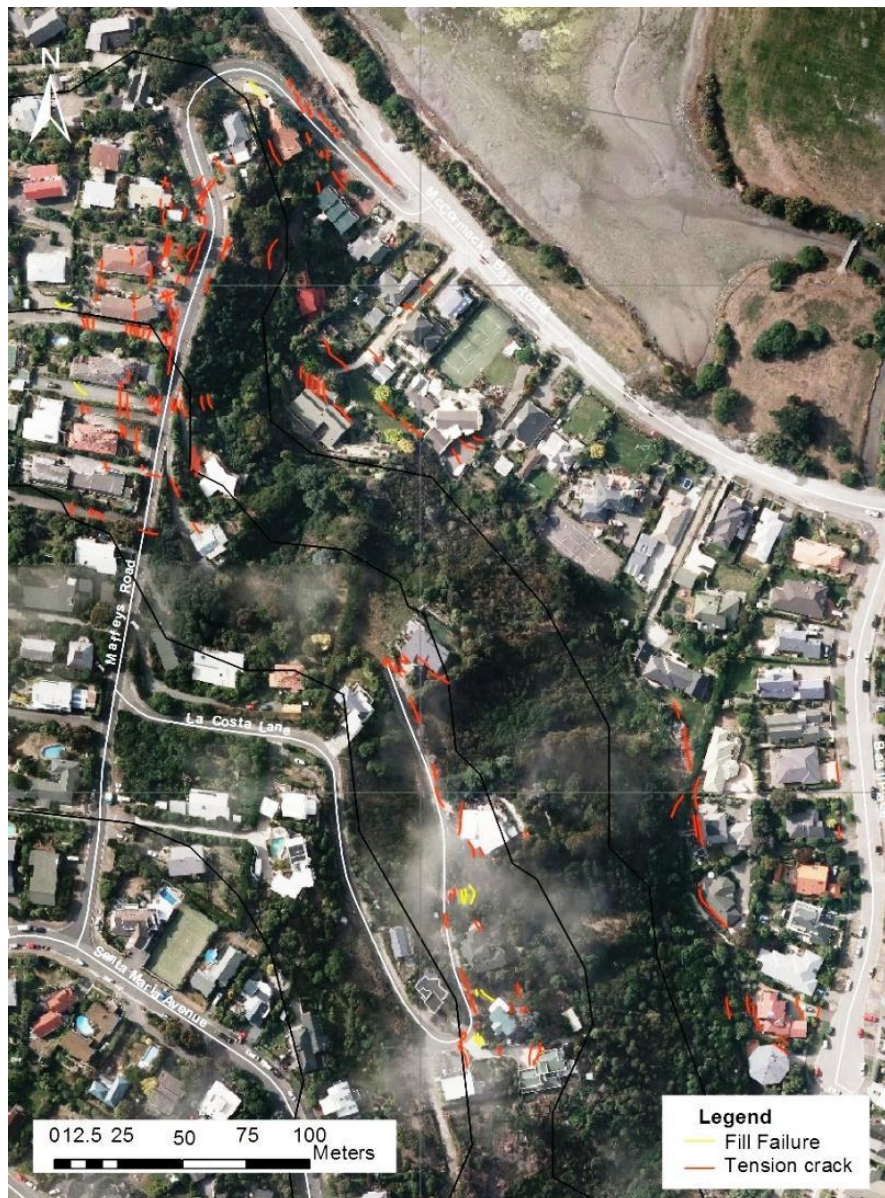
Figure 3.15 Tension cracks at Maffey's Road, La Costa Lane and Basil Place to right. Engel and MacFarlane, unpublished memo, 2011.

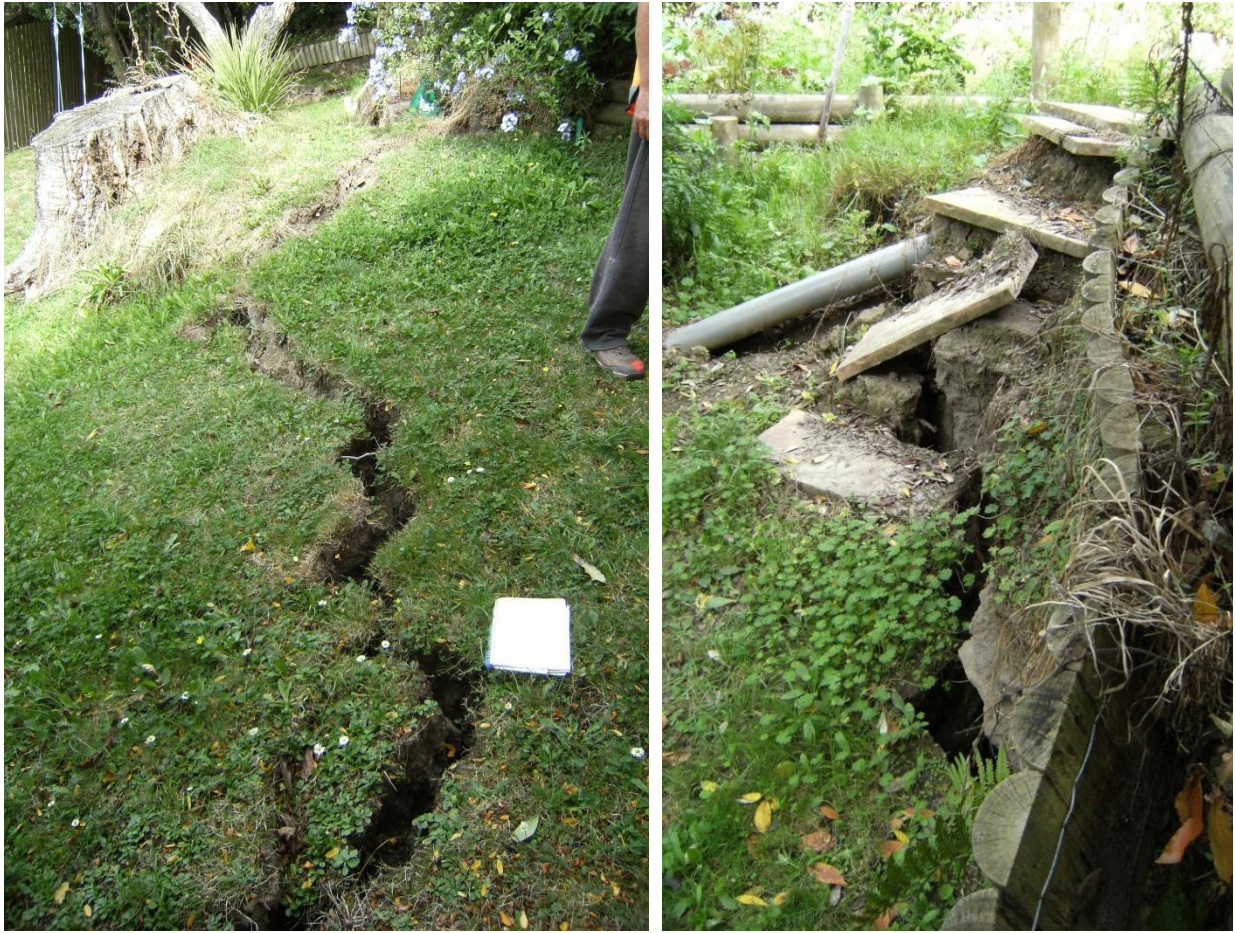
Figure 4.2 Two photos of the tension crack passing through yard of 3 Glenview Terrace, A4 clipboard for scale in left hand image. Vertical displacement in right hand image is ~0.20 m, and horizontal ~0.15 m

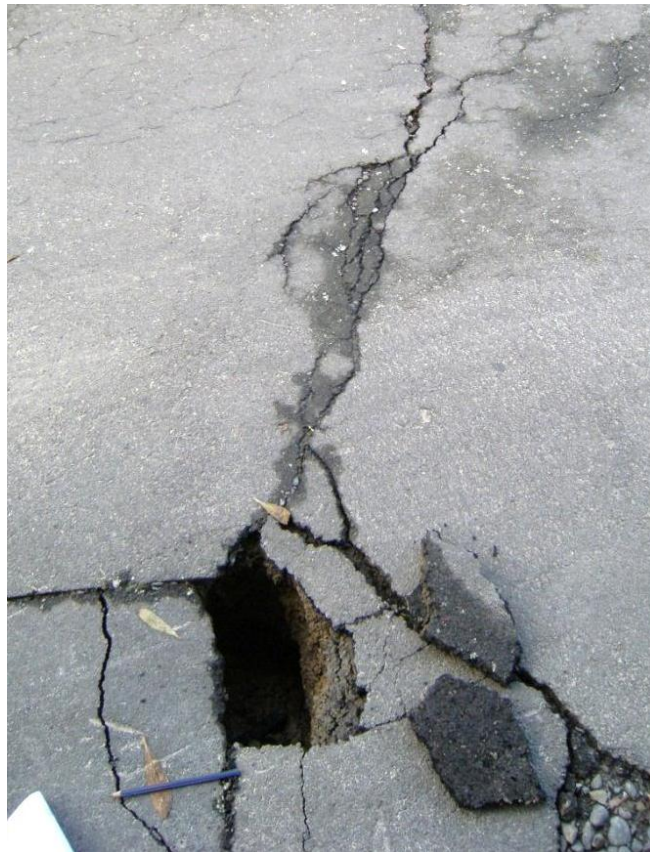
Figure 4.4 Tension crack passing beneath roadway of Glenview Terrace. Cavity beneath road of substantial volume showed loess material was being excavated by water flow. Pencil for scale.

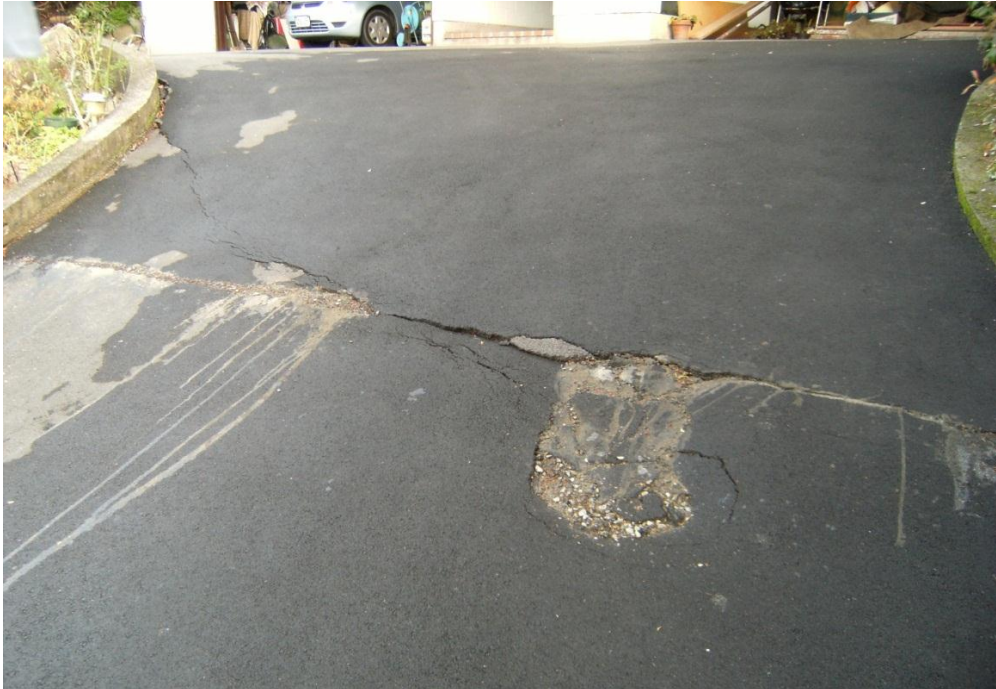
Figure 4.5 Tension cracks passing through driveway of 2 Glenview Terrace. Water was emerging from the cracks at this location, and carrying loess sediment.

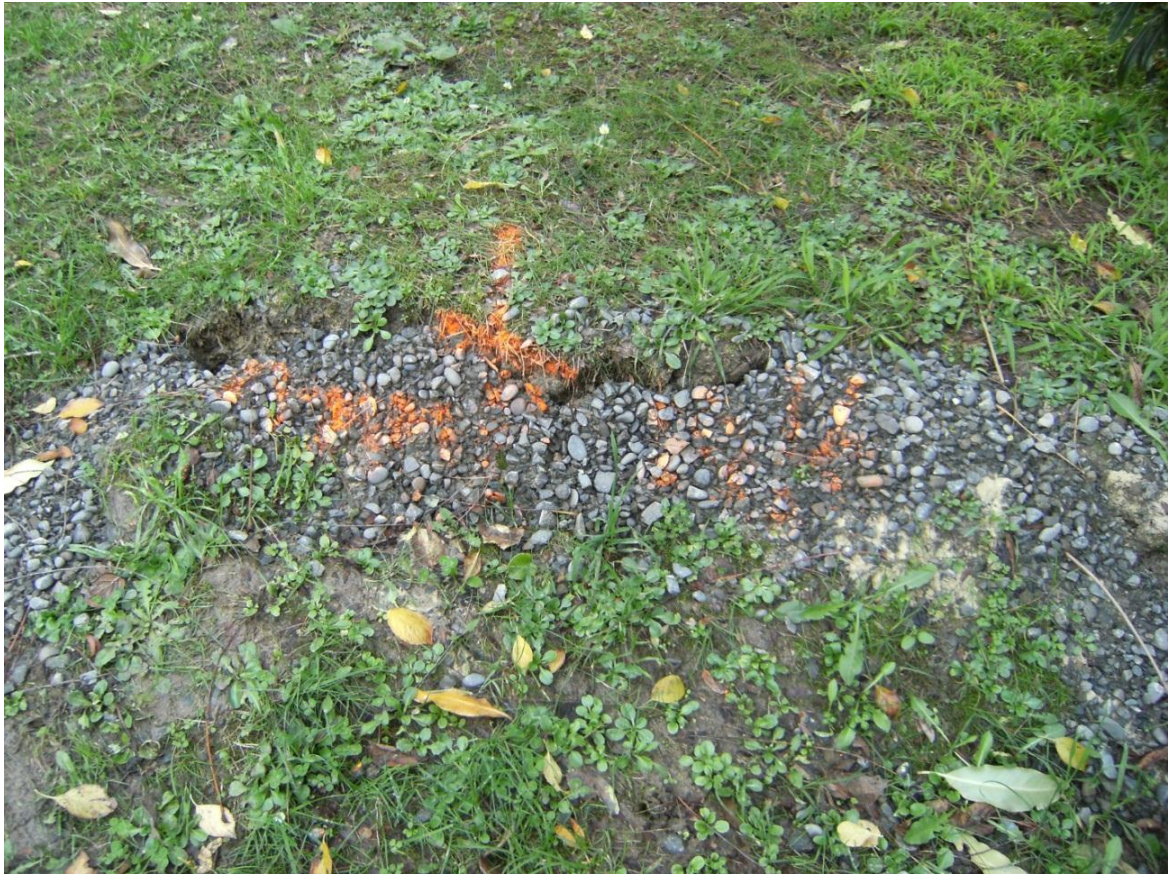
Figure 4.7 Fissure at 3 Glenview Terrace, following remediation infilling with bentonite and SAP-20 gravel. This photo shows the approximately 30 mm subsidence of the fill that was observed on this 30 June 2011 site visit

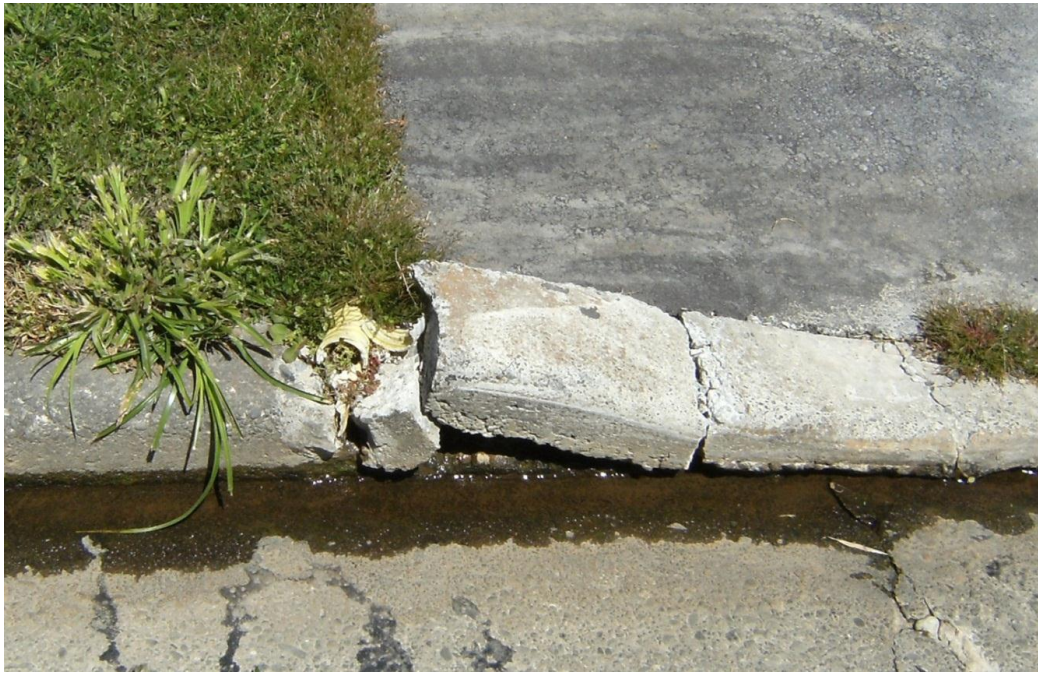
Figure 4.8 Kerbing in Roscoe Street. Such evidence of lateral compression was observed in kerbing at many sites in east-west running streets in the valley floor.

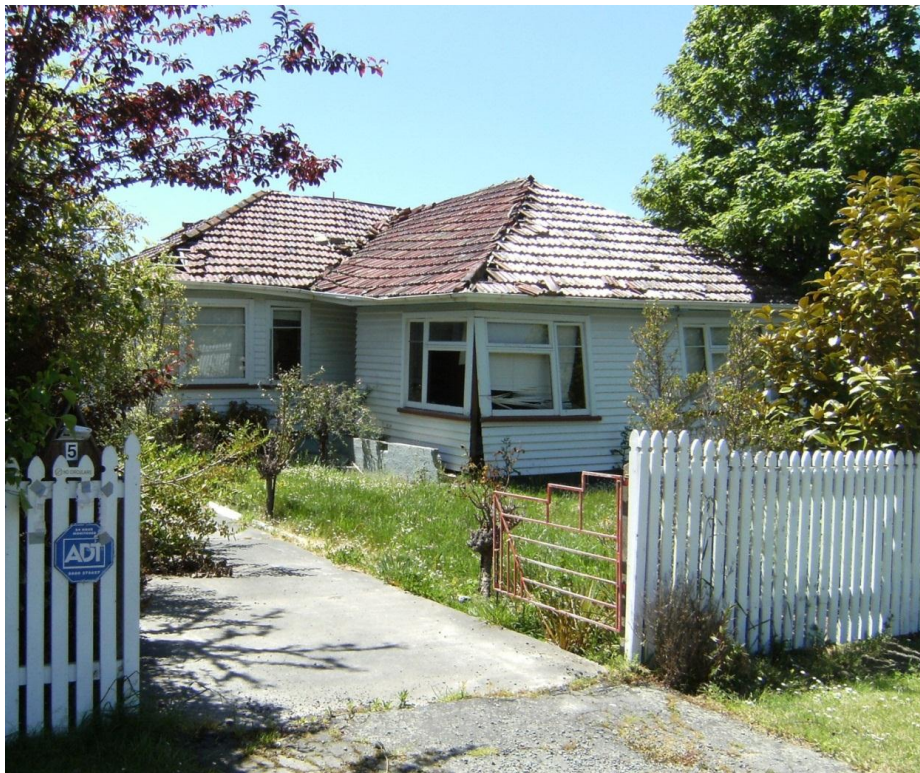
Figure 4.9 Damage to house at 5 Leonard Place. House was located centrally in valley, alongside the channelled stream, and experienced the worst damage after the Darfield Earthquake.

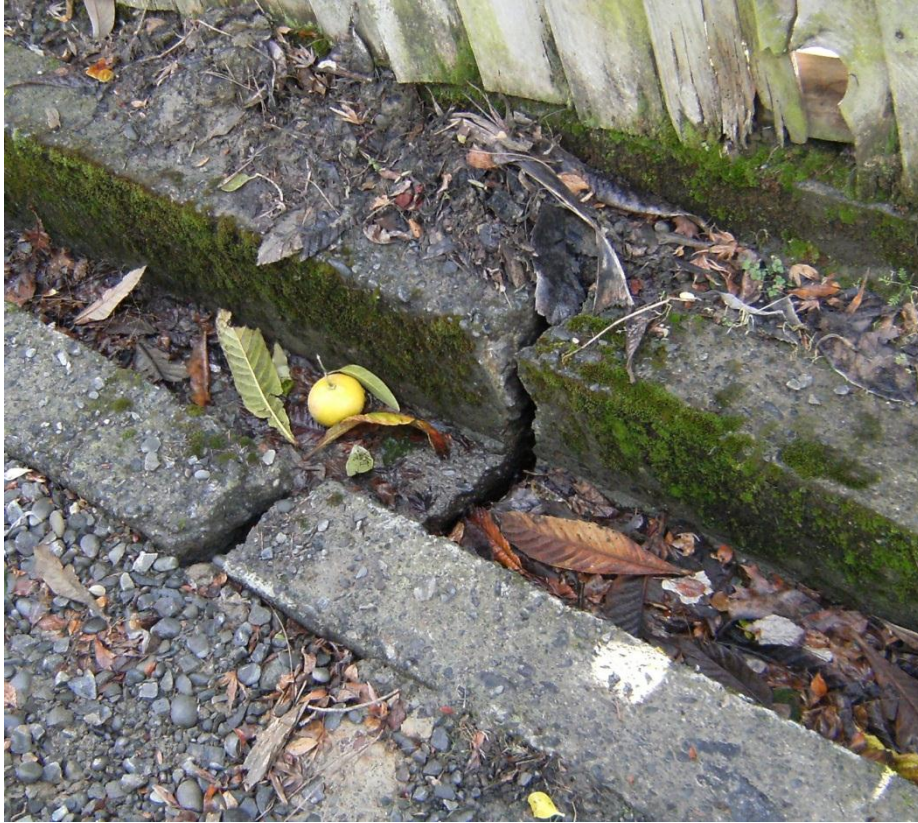
Figure 4.13 Subsidiary fissure trace apparent as approximately 30 mm cracking in kerbing of Glenview Terrace, 20 m up-slope from intersection with Albert Terrace.

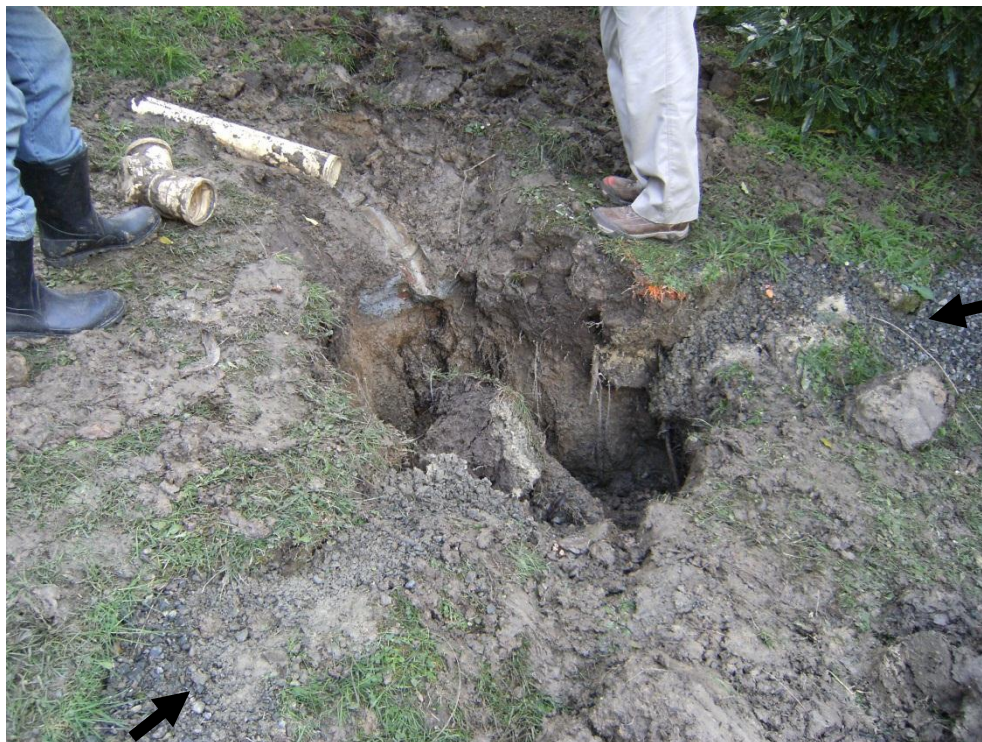
Figure 4.16 The cavity at 3 Glenview Terrace, on July 30th, 2011. Broken drain has been removed back to junction with white pipe shown. Small section of orange dazzle on grass at edge of hole corresponds to dazzle in Figure 4.7. (a) Facing west, fissure trace crossing left to right. (b) Facing north-west, with arrows delineating in-filled fissure trace.

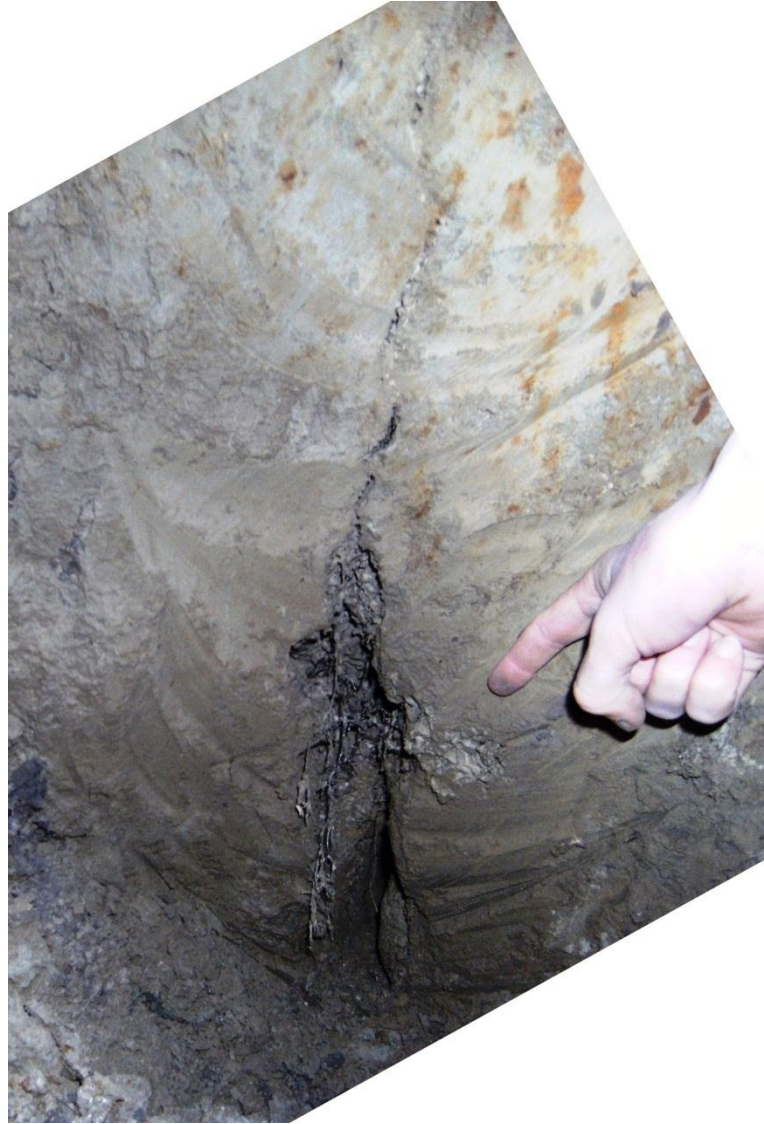
Figure 4.17 Subterranean tunnel-gully exposed in north wall of excavation at 3 Glenview Terrace.

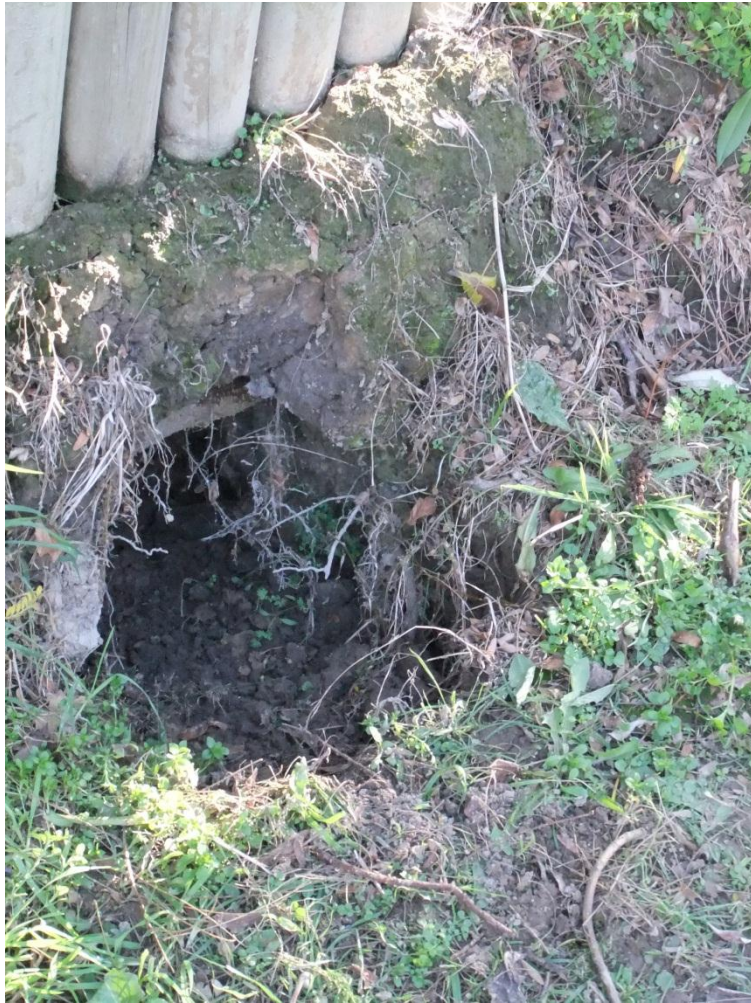
Figure 4.19 Exit-hole of one of three tunnel-gullies observed at 3 Glenview Terrace. Wooden posts have a width of 12 cm.

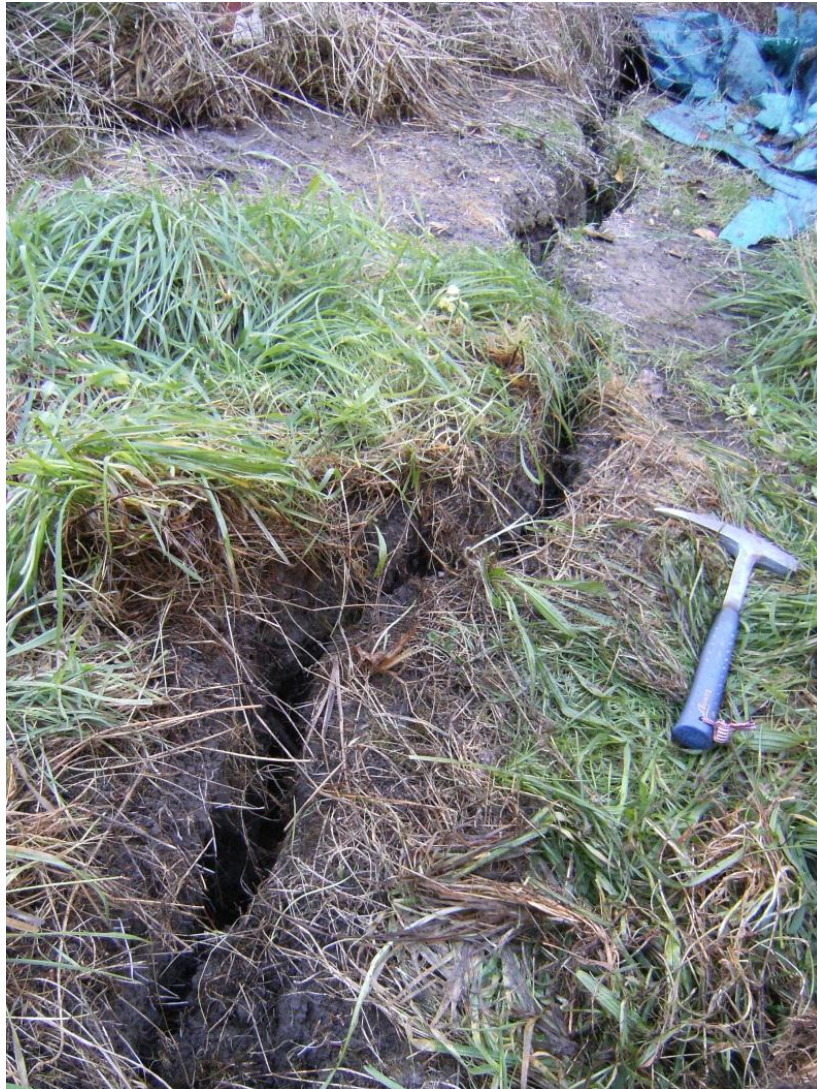
Figure 4.20 Fissure trace through 40 Rapaki Road at the point of greatest offset.

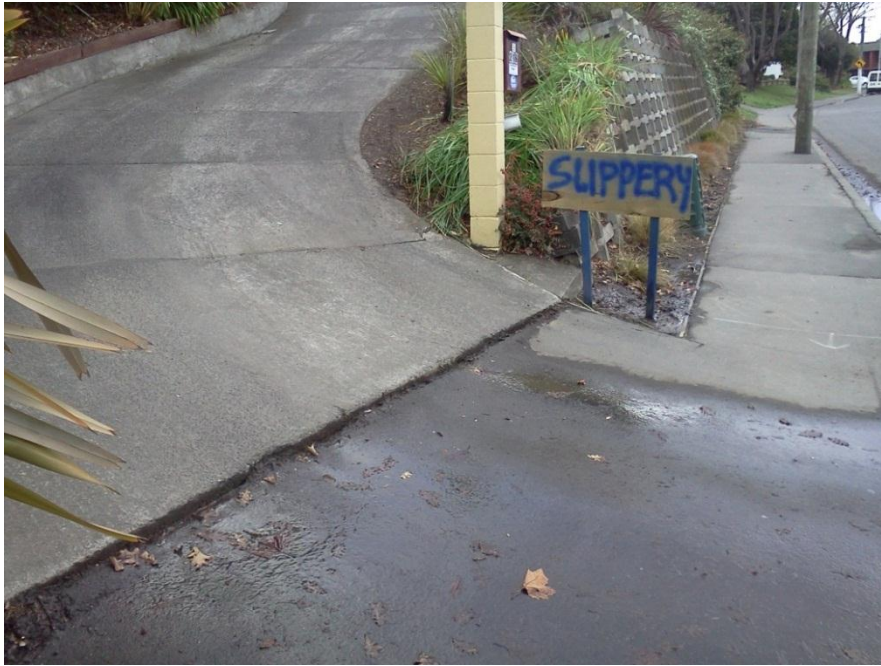
Figure 4.41 Seepage through cracks in paving at base of driveways of 216 (a) and 220 (b) Centaurus Road. Over the substantial length of time that the seepage has been in existence, moss growth has made the paved surfaces slippery.
